ISO 80369-7-Figure C.5

Female Reference Luer Slip Connector For Testing Male Luer Connectors

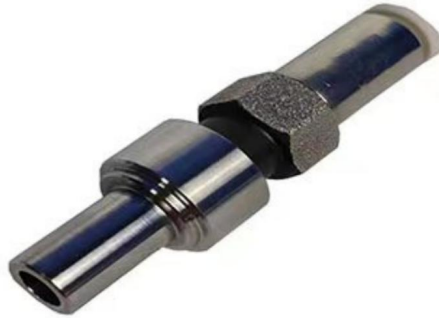
This ISO 80369-7 Figure C.5 compliant female reference luer slip connector is specifically designed for testing male luer connectors according to international standards. It serves as the reference device for evaluating leakage resistance, separation force under axial load, stress cracking susceptibility, and non-interconnectable characteristics with other small-bore connectors.

Place Of Origin	China	Brand Name	Kingpo
Certification	ISO 17025 Calibration Certificate	Model Number	ISO 80369-7-Figure C.5
Standard	ISO 80369-7-Figure C.5	Material	Hardness Steel
Hardness	HRC58-62

- Precision Machined - Exact dimensions per ISO 80369-7 Figure C.5 specifications
- Material Compliance - Made from materials specified in the standard for accurate testing
- Multi-Purpose Testing - Validates leakage, axial separation, stress cracking and non-interconnectability
- Quality Assurance - Each unit comes with certification of compliance
